INSTALLATION RESTORATION PROGRAM

PRELIMINARY ASSESSMENT

186th Tactical Reconnaissance Group Mississippi Air National Guard Meridian Airport, Key Field Meridian, Mississippi

OCTOBER 1988

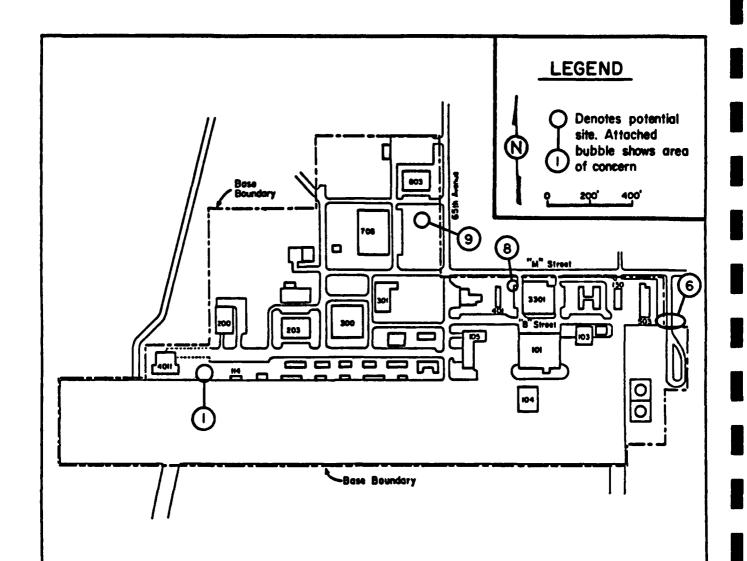
Figure 7. Location of On-Base Potential Sites for the 186th TRG, Mississippi Air National Guard, Key Field, Meridian, Mississippi (1988).

Interview information revealed that spent solvents, waste oils, and other flammables in addition to JP-4 fuel were burned in this area. Before the flammables were applied to the FTA, a water base was applied prior to the burn to help retard the infiltration of the flammables into the soil.

Training was generally done six times per year with no multiple burns. On this basis, using 250 gallons of flammable liquids per exercise, it is estimated that 1500 gallons of waste were used per year. Assuming that up to 70% of the flammables released at the FTA were destroyed, an estimated 450 gallons per year may have remained either to evaporate or to percolate into the ground. A potential total of 2250 gallons of waste may have infiltrated into the ground during the 5-year period this FTA was in use.

Based on the investigation documented in this PA and the HARM scores the nine identified sites received, it is recommended that further IRP action be implemented.

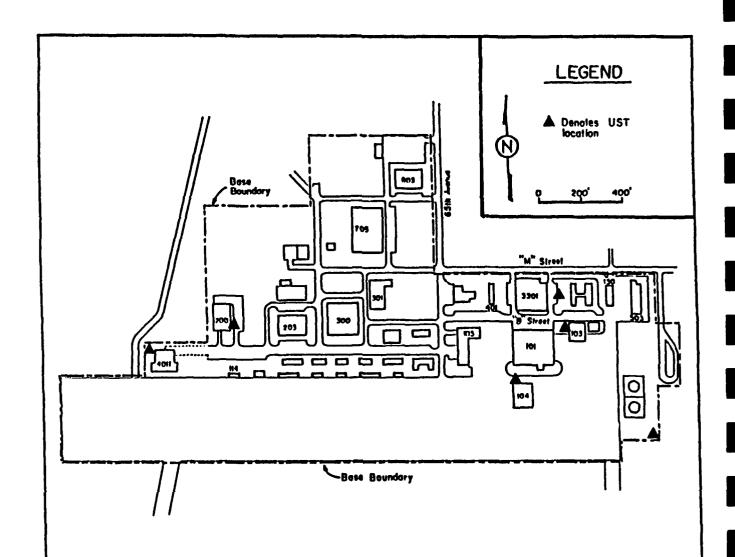
Figure 9. Locations of Underground Storage Tanks, 186th TRG, MSANG, Key Field, Meridian, Mississippi (1988).

- o There are six Underground Storage Tanks (USTs) on the Base property for which the ANG is responsible (Appendix E). Five of the six USTs are associated with the holding tanks for the Oil/Water Separators. The remaining UST is associated with the Motor Pool (Building 3301) for MOGAS storage. There is no evidence to indicate that any of these tanks are leaking and all are presently in service.
